U. S. NAVAL AIR ENGINEERING CENTER

NAEC-ENG 7898

04 Jun 1976

INFLUENCE OF WIRE PROPERTIES
ON THE FATIGUE PERFORMANCE
OF ARRESTING GEAR PURCHASE CABLE

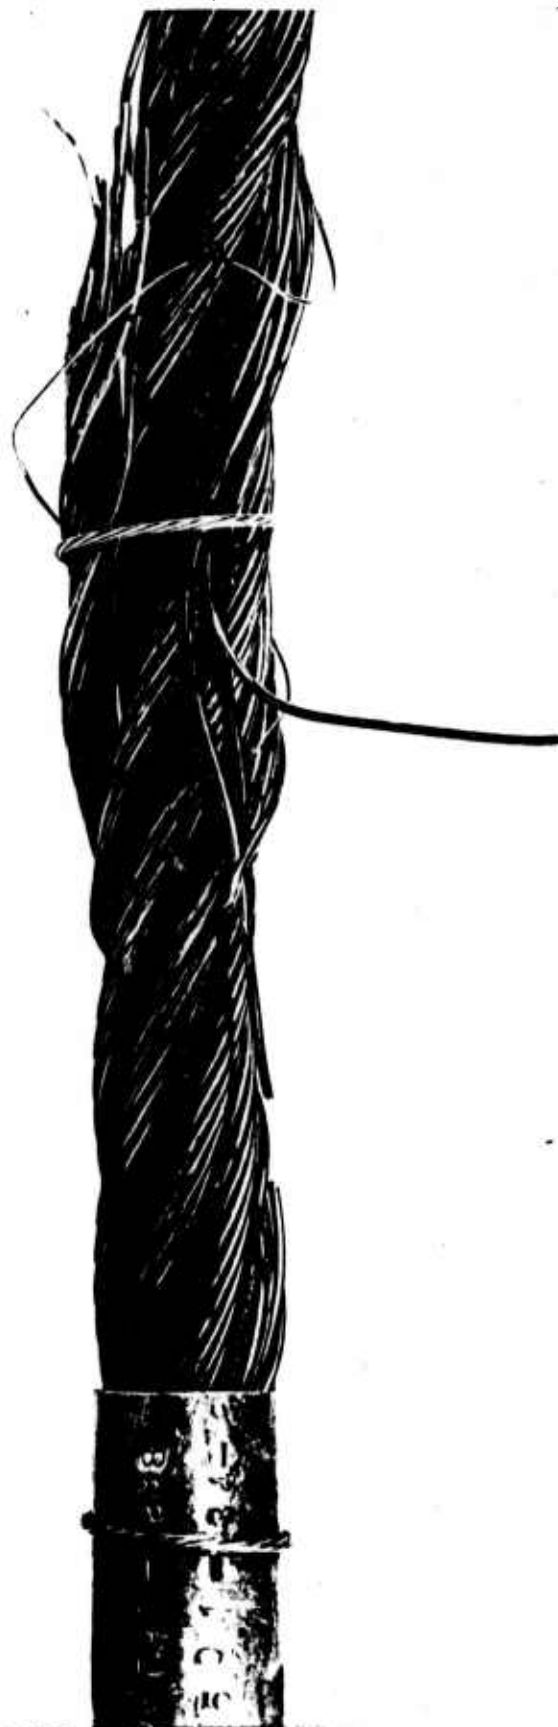
FIGURE 1

A typical break in wire rope that failed in fatigue is shown in Figure 1. This sample is from N-501-34-2 which failed after 7481 cycles. The fatigue test is stopped after the first sharp report indicating the breaking of one strand, but oft times, a second strand might partially or completely break.

Wire Rope That Failed in Fatigue

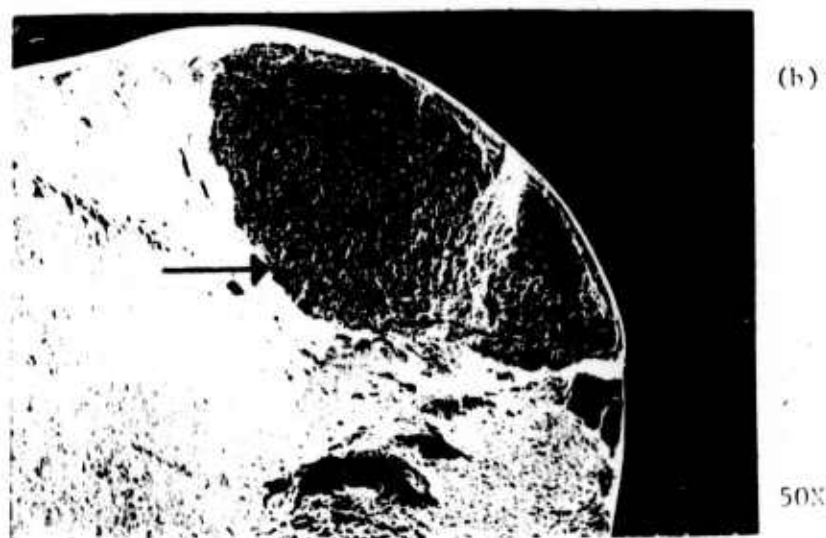
MODE 2A 1: Showing Fatigue
FIGURE 3

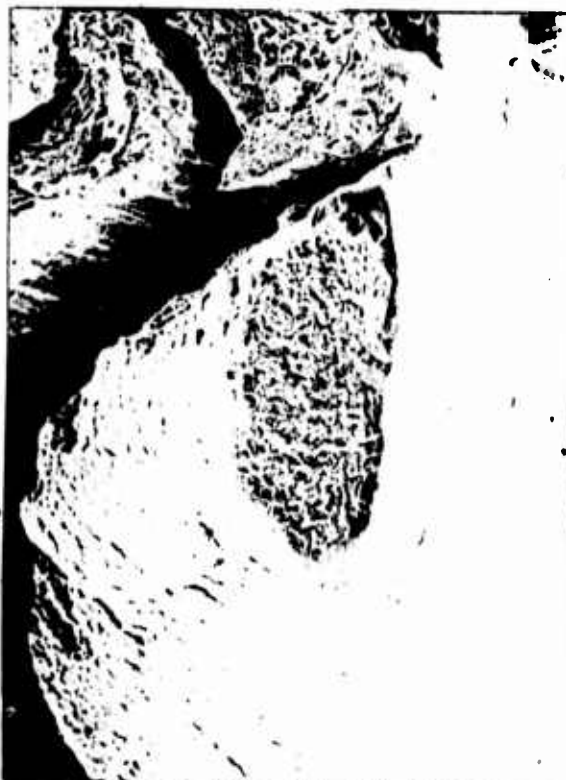
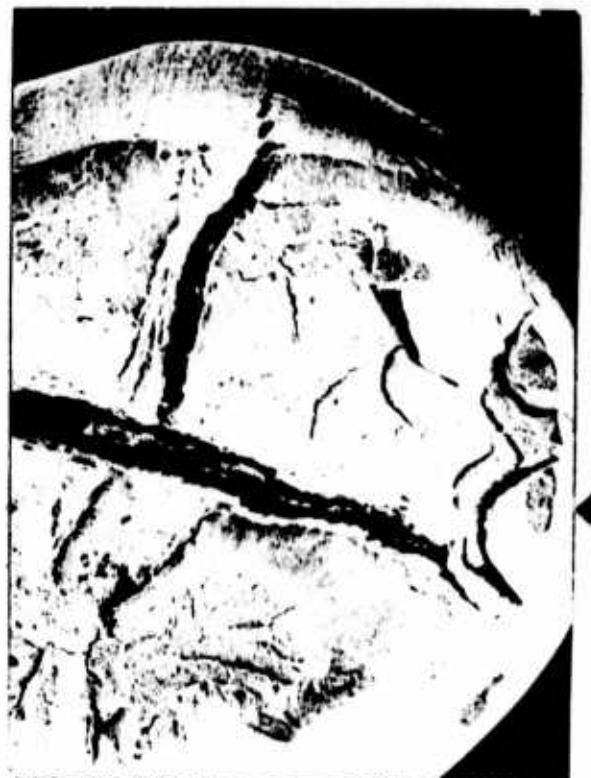
MODE 3A₂: Showing Fatigue
FIGURE 4

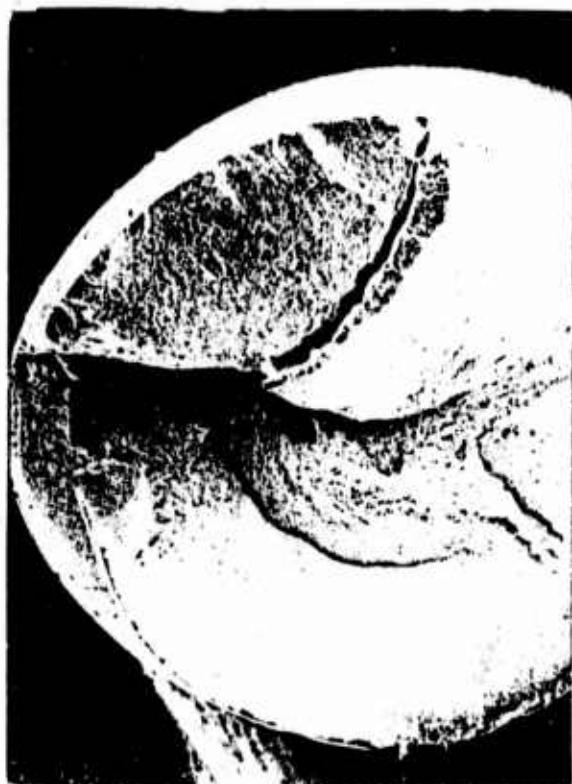
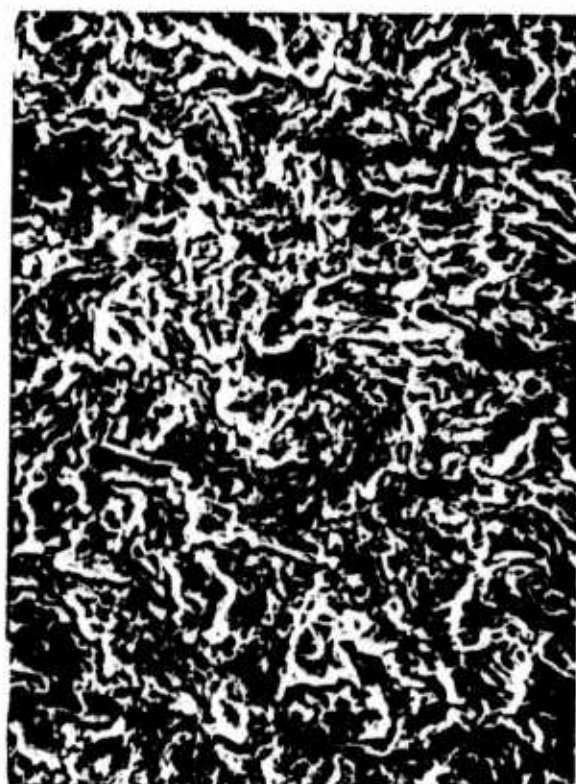
MODE 4A1: Showing Fatigue
FIGURE 5

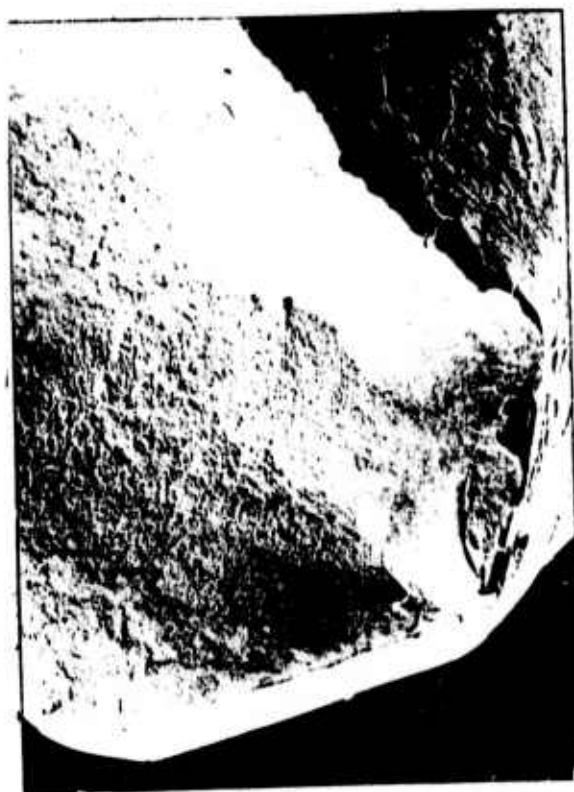
FIGURE 6

MODE 1A: Showing No Fatigue (1975 Contract outer lay wire)

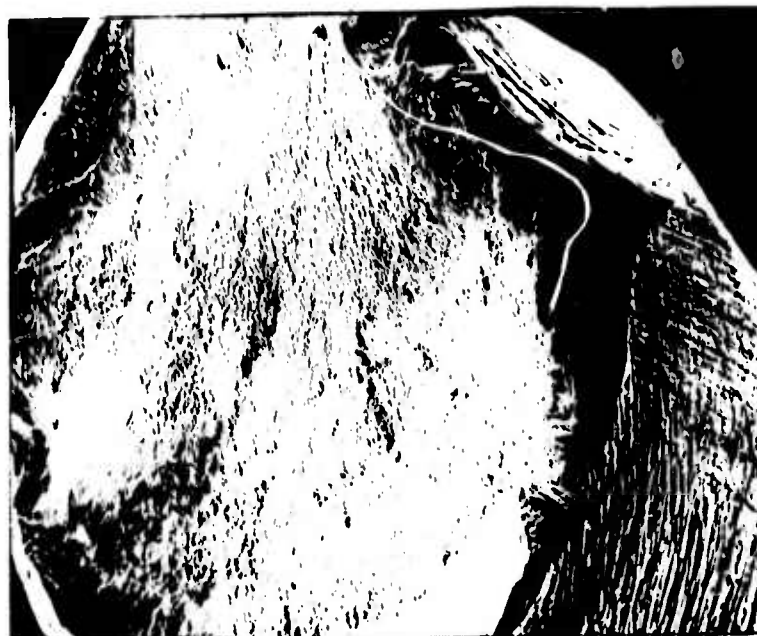
FIGURE 7

MODE 1B: Shows No Fatigue (1975 Contract Outer Lay Wire)

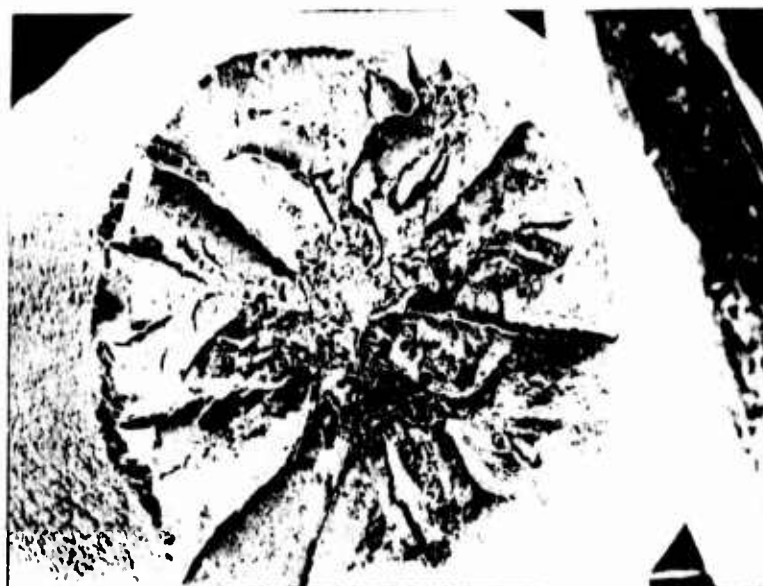
FIGURE 9

MODE 3A₁: Showing No Fatigue

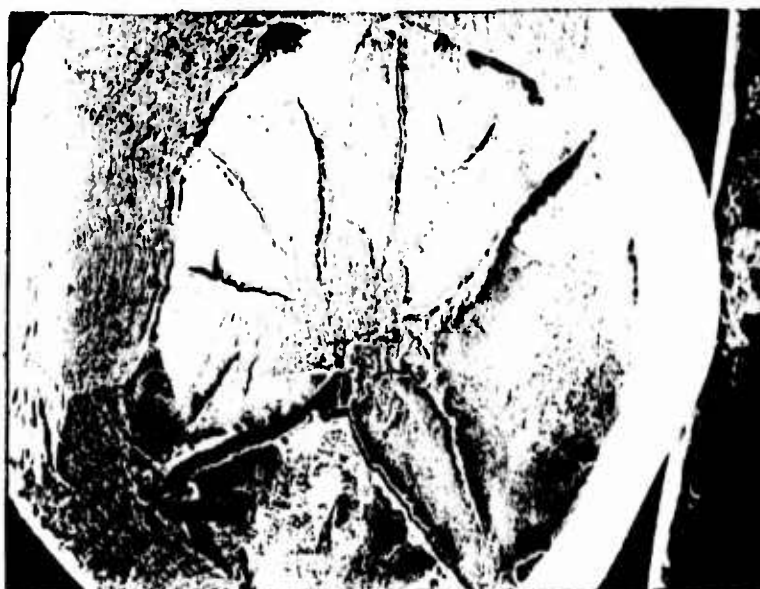
MODE 3A₂: Showing No Fatigue
FIGURE 10

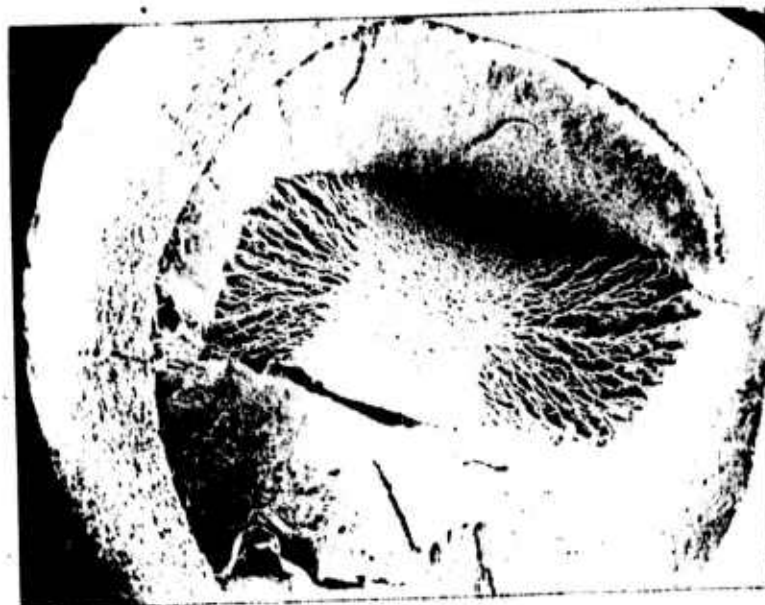
MODE 4A₁: Showing No Fatigue (1975 Contract Outer Lay Wire)
FIGURE 11.
